## Application of total quality management tools in the risk analysis of pathologies in steel-structured buildings

Giane Alfenas Antunes Hofmann<sup>1\*</sup>

Henor Artur de Souza<sup>1</sup>

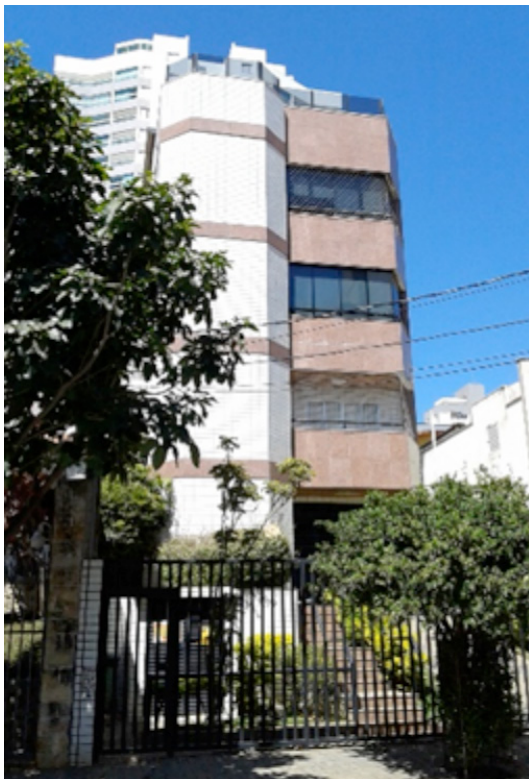
Figure 2. Building 1.

Building 1 (Figure 2) with three floors, was built in 2000, with a steel structure (non-parallel laminated profiles). The external vertical closure is in perforated ceramic brick, and the internal one is in precast reinforced concrete panels. The slabs between floors are made of precast reinforced concrete panels. The labor was contracted for that project. The company needs a staff training program or a systematic plan to introduce new technologies on site.

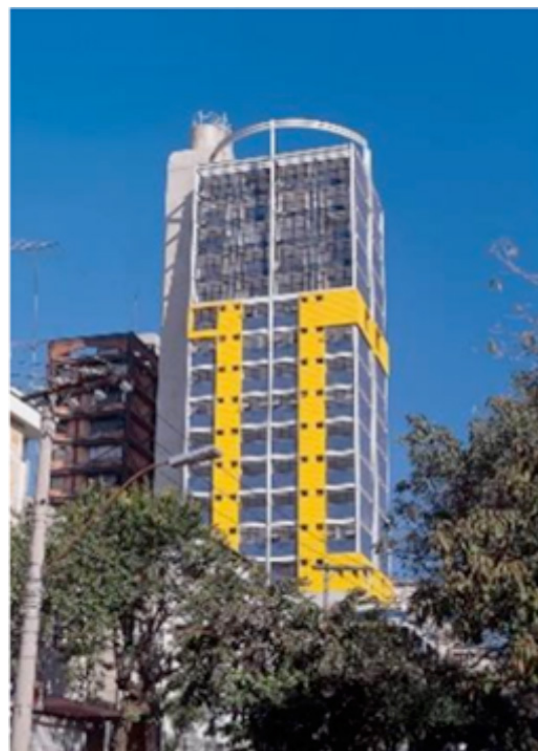
Figure 3. Building 2.

Building 2 (Figure 3), with nineteen floors, was built in 1998, with a steel structure (welded profiles, not visible). The external vertical closure is made of masonry of cellular concrete blocks, and the internal one of plasterboard. The slabs are steel, with embedded formwork. The labor was hired by specific service, by contract, and so no training program was adopted, outsourcing most of the work and only managing the construction assembly.

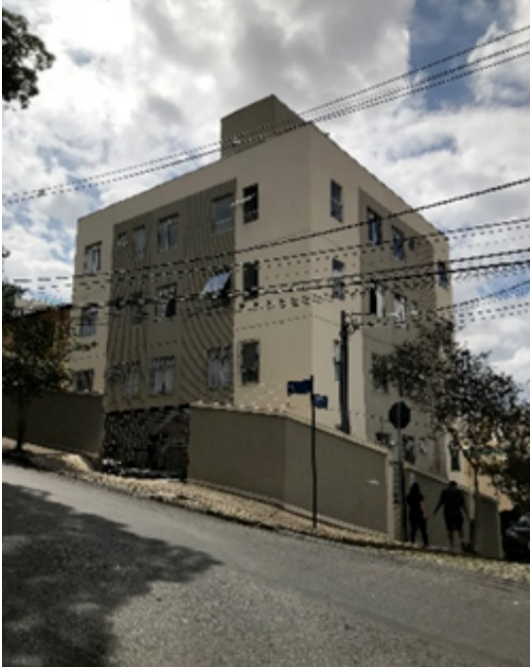
Figure 4. Building 3.

Building 3 (Figure 4), with three floors, was built in 2000, with a steel structure (light profiles, not visible). The external vertical closure is in reinforced concrete panels with an expanded polystyrene

core, and the internal closure was executed with plasterboard panels. The slabs are steel, with embedded formwork. The company does not have a permanent team of employees and does not have a training program; thus, the work has been carried out under contract.

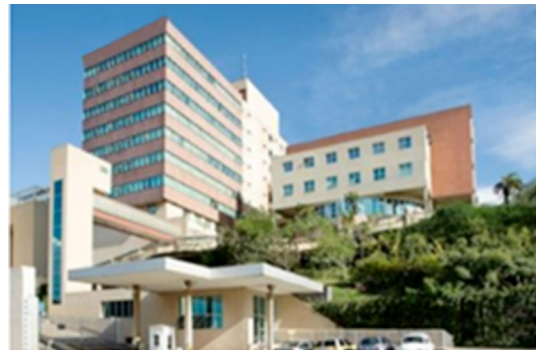
Figure 6. Building 5.

Building 5 (Figure 6), with nine floors, was built in 2000 with a steel structure (welded profiles, not visible). The exterior vertical enclosure is made of autoclave-treated cellular concrete panels and the masonry of cellular concrete blocks. The internal vertical enclosure comprises gypsum panels, and the floor slabs are in-situ concrete. The site labor was, almost in its totality, hired by service companies that sold the respective construction component systems to the construction company, which took on the role of coordinating the process.

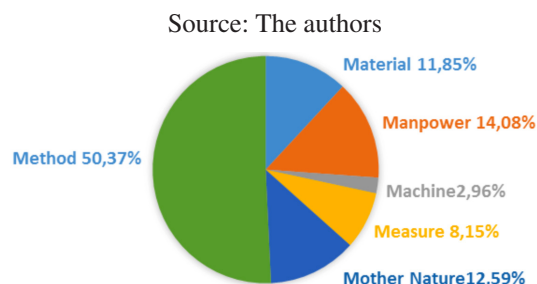
Figure 7. Percentage of 6M causes.

Observing the data presented in Analyses 1 to 10, 134 possible causes are listed for the ten pathologies presented and indicated in the work of Bastos [17]. Of these causes, 16 are related to raw material, 19 are related to labor, 3 are related to machinery, 11 are related to measures, 17 are related to the environment, and 68 are related to the method.

It can be seen, therefore, that the way of construction or the resolutions contained in the project are responsible for the absolute majority of pathologies, representing 51% of the possible causes of pathologies in the surveyed buildings (Figure 7). The method can mean design determinations (or the lack of them) and the execution practice at the construction site. Some construction techniques may present themselves as insufficient in preventing pathology and will only present consequences in the future. Other times, some construction methods may have needed to be addressed due to sloppiness or economy. As stated by Castro [14], the presence of pathologies is explained by greed, ignorance, or carelessness.
